Current Status of Linac & SR RF System

Young-Do Joo

November 13, 2023

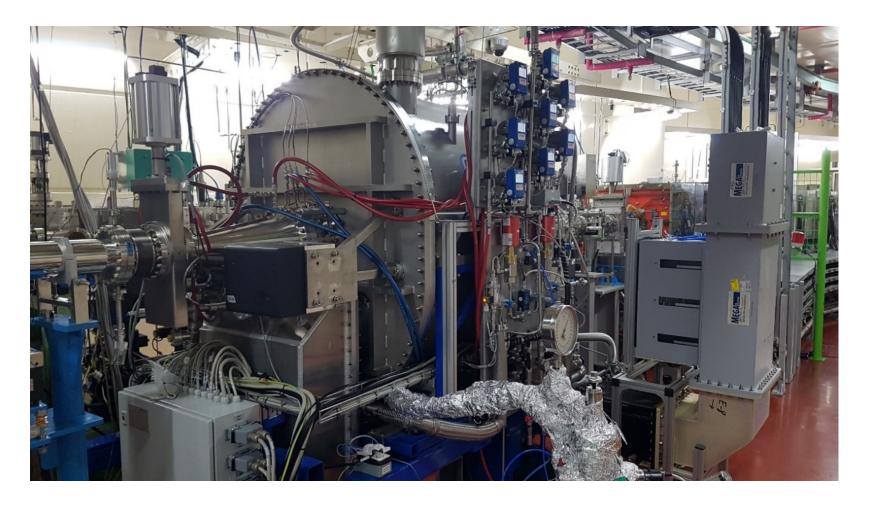
A Repairing CM1 is on going now

- -FAT is scheduled in early December
- -CM1 will arrive at PAL in early February
- -After warm leak test, CM1 will be stored as a spare

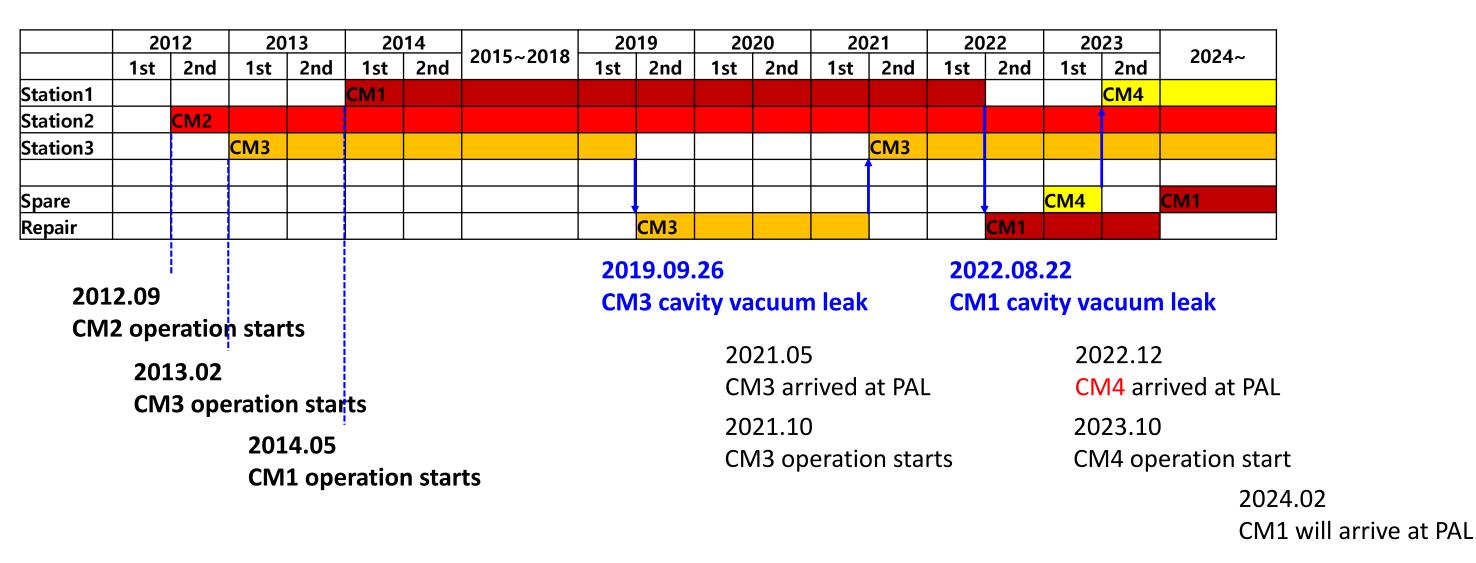
Cryomodule history

Total 4 CMs: 3 active, 1 spare
Only needs 7~8 weeks to replace CM, He vessel conditioning and RF conditioning

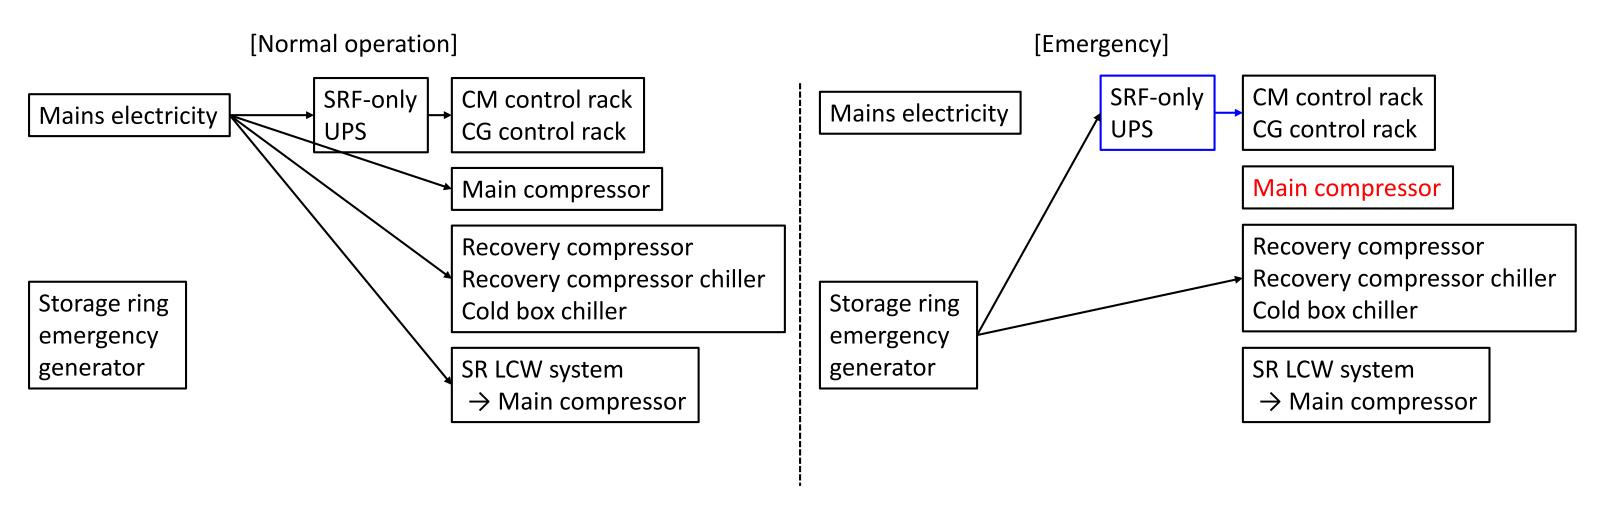
***** Before

- -Only Cryogenic and Cryomodule control system was uninterruptible
- -If there occurs a voltage drop or power failure with a large enough impact to stop the main compressor, the main compressor will stop. This requires a lot of time to recover.

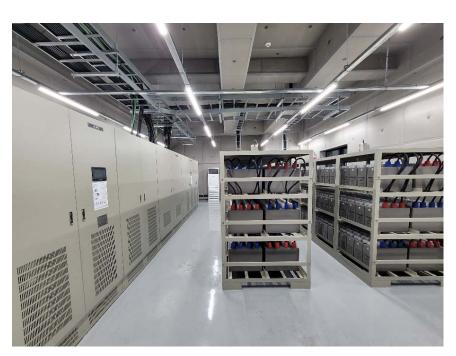
SRF-only UPS

-SRF-only UPS

30 kVA (x2 in parallel) \rightarrow 500 kVA (x2 in parallel) : Enough capacity to operate main compressor during 15 min.

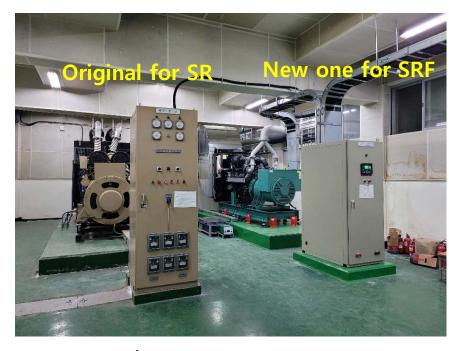
SRF-only Emergency generator

-SRF-only Emergency generator

A new SRF-only emergency generator (750 kW): can be activated in 30 seconds

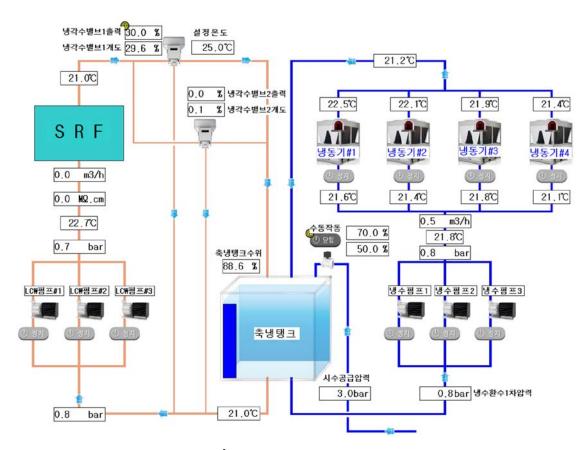
SRF-only LCW system

-SRF-only LCW system

LCW pump system and LCW cooling system for main compressor

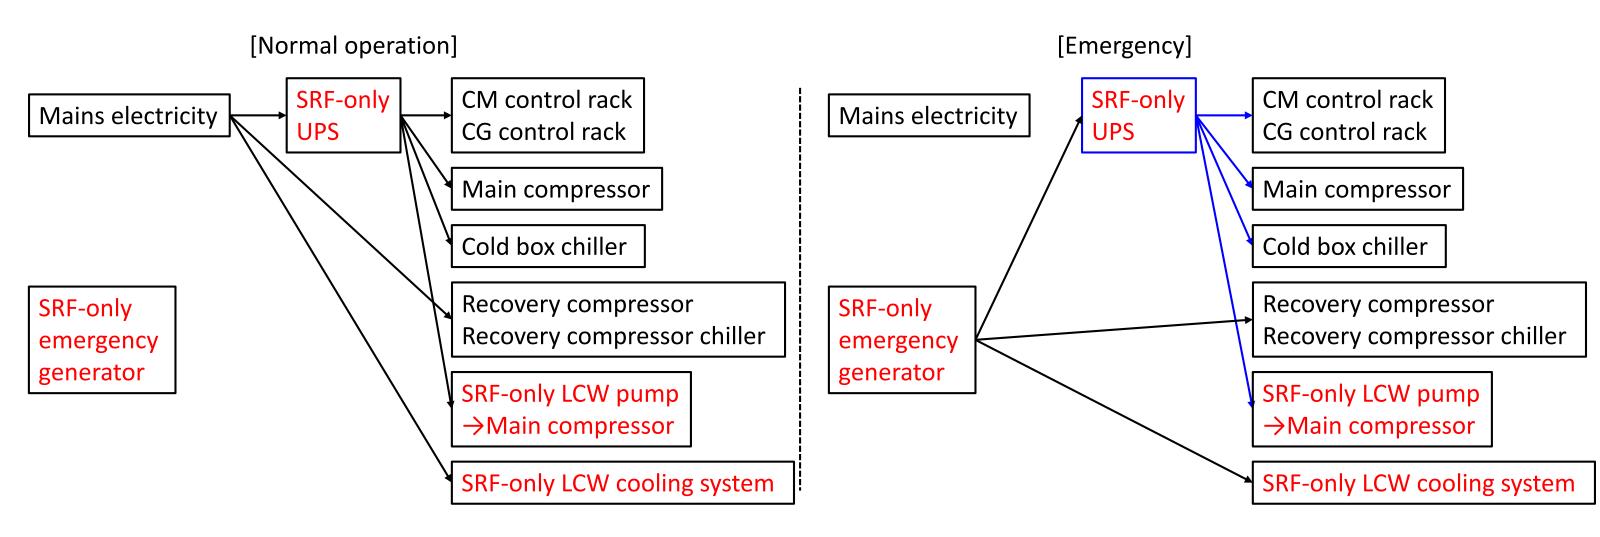
❖ After

- -Full electricity system is uninterruptible
- -SRF LCW system can stand alone operation

Full uninterruptible system will operate from next year

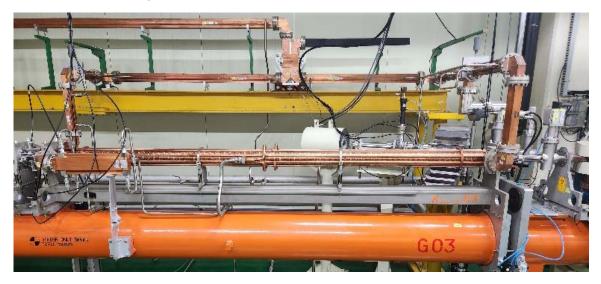
❖ Before replacement (IHEP)

- -Of the 46 accelerator tubes in the linear accelerator, 42 are IHEP-made accelerator tubes (used for about 30 years), and 4 are Mitsubishi accelerator columns (2 each for sections 12A and 12B).
- -MK2A has frequent tunnel vacuum faults even at lower high voltage (36 kV) than other modules, making it difficult to supply enough RF power. This is due to frequent vacuum interlock caused by arcing in the accelerator column.
- -Replacing two accelerator columns of MK2A with spare (Mitsubishi) to increase RF Power

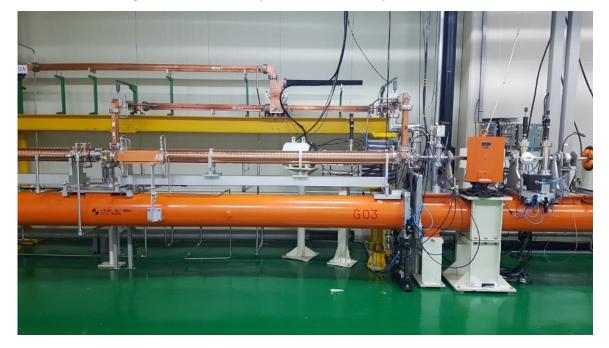
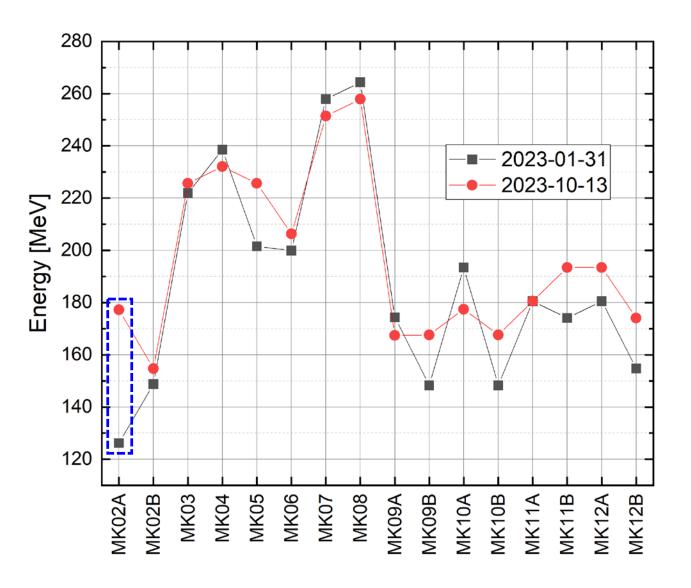
After replacement (Mitsubishi)

-Beam energy of each station was measured by turn off MK one by one
